Truck Mixer Wedged Under Bridge

LOCATION:	ON-HIGHWAY	ALERT STATUS:	Normal
ACTIVITY:	TRANSPORT & LOGISTICS / DELIVERY	DATE ISSUED:	14/09/2011
SUB ACTIVITY:	MOBILE PLANT	INCIDENT No:	00311

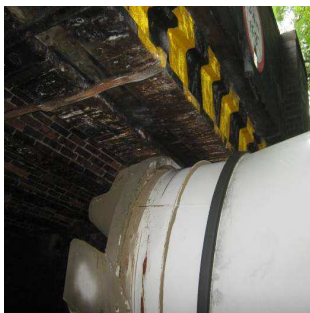
A truck mixer was carrying a load of concrete to a customer site, on route the driver encountered a low bridge and knew that it would be tight to go under the bridge, he slowed and put the vehicle in 1st gear. On exiting the bridge there was a steep incline causing the drum ring to wedge under the bridge. The vehicle could not go forwards or backwards.

The police and Network Rail were informed and the railway closed for 46 minutes until the vehicle was freed by releasing air from the tyres. The investigation has found that the bridge height indication was 11ft 3 inches and when measured, the height of the truck was 12 ft 2 inches. The driver did not know the height of his vehicle and it was not indicated in his cab.

Wedged under Low Bridge

- If a vehicles overall travelling height or trailer exceeds three meters there must be a notice in the cab, where it can be easily read by the driver.
- The notice must indicate the overall travelling height of the vehicle (to a tolerance of plus 150mm) in feet / inches or both feet / inches and meters, (but not in meters only).
- The numbers in feet/inches must be at least 40mm tall
- The requirement of the notice is not covered in an MOT test
- Importantly the driver must know the height of his vehicle and not take the risk.
