Truck Mixer Driver Fall

WHAT HAPPENED

ALERT STATUS: Normal
DATE ISSUED: 12/12/2011
INCIDENT No: 00318

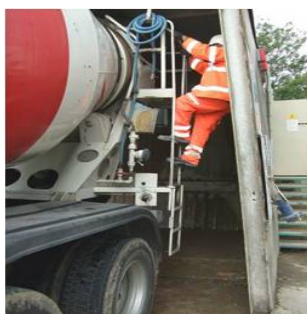
Climbing up to the access platform, the driver coiled away the hose and then started to descend the ladder. During this descent his foot slipped off the 5th rung of the ladder (measured at 1.6m from ground level). As he fell to the ground, he landed heavily on his right foot, chipping a bone in his ankle; not only was he in some pain, being self employed he is now unable to work for several weeks.

Position from where driver fell

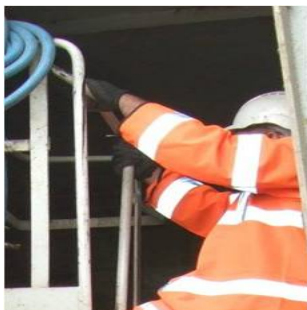
- As he descended the ladder, instead of holding onto both vertical hand rails he used the swing bar as one of his 3 points of contact:
 - Are employees and contractors reminded of the need to GET a GRIP, and maintain three secure points of contact when using ladders and stairways? Is this monitored by site supervision? In this case, the Driver relied on the self closing gate as a point of contact. Have we explained that hinge mechanisms on self closing gates and swing bars should not be used as hand holds? They can easily fail and, as happened in this incident, can cause a person to lose their grip and fall.

- The swing bar was bent out of shape causing it to close below its fixing bracket:
 - do we have robust inspection systems in place to ensure this type of defect is identified and corrective action taken?

Renactment showing driver holding swingbar

- Records indicate that the driver had not received GET a GRIP training for over three years:
 - Do we regularly remind employees and contractors of key health and safety messages, for example in this case by inviting them to attend Drivers Safety Workshops, the Drivers Handbook briefings and New Year back to work training sessions?
