# Tipper Tail Gate

ALERT STATUS: Normal  
DATE ISSUED: 27/03/2012  
INCIDENT No: 00330

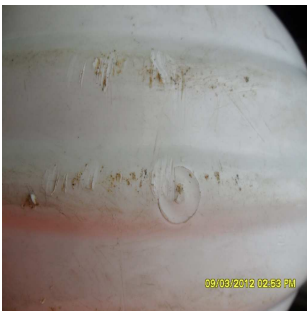
Hard Hat

The driver had put the lower tailgate up to clean the ledge and while carrying out the cleaning, the tailgate weighing Approx 50kg swung down, hitting him on the top of his safety helmet. Fortunately because he was wearing his safety helmet the driver did not suffer a very serious injury.
