# Hot Bitumen Burns

LOCATION: ASPHALT/COATING PLANT  
ACTIVITY: TRANSPORT & LOGISTICS / DELIVERY  
SUB ACTIVITY: PRODUCT DELIVERY

ALERT STATUS: Normal  
DATE ISSUED: 06/07/2012  
INCIDENT No: 00334

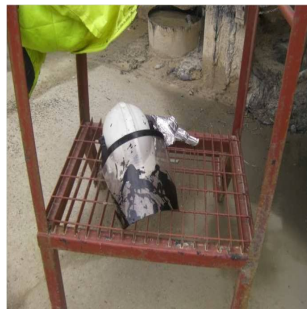
Visor
