## Fatal Incident - Cyclist

**ALERT STATUS:** High Potential  
DATE ISSUED: 12/07/2012  
INCIDENT No: 00335

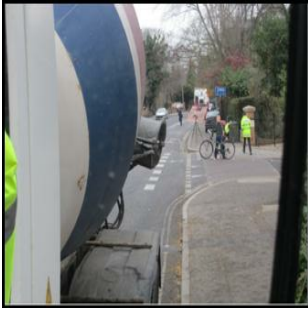
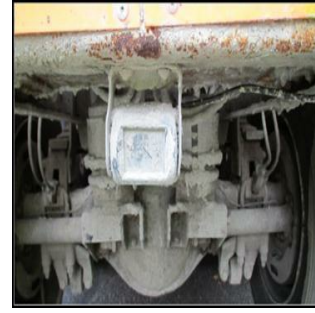
A young female cyclist was fatally injured at a T-junction when she was struck by a truck mixer that was being driven by a contract driver. The following is based on the police reconstruction of the incident and may change should further evidence become available. The driver of the truck was travelling along a main road and wanted to turn his vehicle around and travel back the way he had come; the road is two way with single opposing carriageways. As he passed the junction, the driver moved over into the opposite carriageway, facing the oncoming traffic, and reversed into a side road. It is believed witnesses to the incident saw the cyclist in the centre of the side road, waiting to turn onto the main road at the T-junction. As the driver exited back onto the main road, it seems the front nearside of the truck struck the cyclist, despite the efforts of one witness to alert him to the danger. The driver was arrested at the scene and has been charged with “causing death by careless driving”.

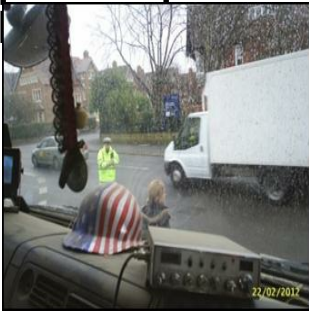
There were a number of items obstructing forward vision and view of the mirrors from the driver's

position. Are drivers aware of the need to ensure their field of vision and view of their mirrors is maximised to reduce the potential for 'blind spots' around their vehicles?

It was commented by the Police that the kerbside close proximity mirror was incorrectly aligned. Do drivers know how to check and adjust their mirrors so that they are correctly aligned?

The reversing camera monitor was positioned on the far side of the cab, away from the driving position, the lens was dirty and an intermittent fault resulting in picture loss was observed during the reconstruction. Are monitors located where the picture can be clearly seen, without obscuring forward visibility? Are cameras kept clean and monitors checked to ensure they are fully functional?

Housekeeping inside the cab was poor, with debris and equipment stored in the passenger foot well. Are the cabs of vehicles kept clean, with all items secured, to ensure nothing interferes with their safe operation, or causes injury in the event of a collision?
