Steel Fibre Penetrates Knee Cap

READYMIX OR MORTAR PLANT
MANUAL HANDLING AND STORAGE
N/A

ALERT STATUS: Normal
DATE ISSUED: 27/11/2012
INCIDENT No: 00345

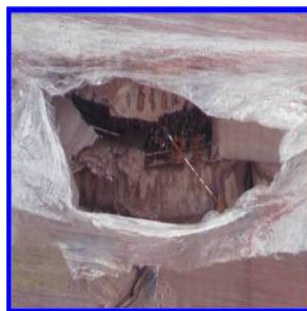
The employee had been given the task of loading truckmixers with the fibres, emptying them from cardboard boxes onto a mobile conveyor. The boxes had been stored outside on pallets under plastic covers. Due to heavy rain the boxes had become soft and were breaking down, causing the fibres to spill onto the ground.

Damaged Boxes

- Are materials stored correctly on site?
- Is housekeeping maintained to a high standard with weather conditions accounted for?
- Are tasks correctly risk assessed and Safe Systems of Work or Safe Operating Procedures developed?
- Is consideration given to individual capability and workload when planning a new activity?
- Are problems with materials and equipment reported?
- Is it ensured operatives have breaks at correct intervals, with job rotation being used as appropriate?
- Do you use the Near Miss / Hazard Alert system to highlight any potential health and safety issues?

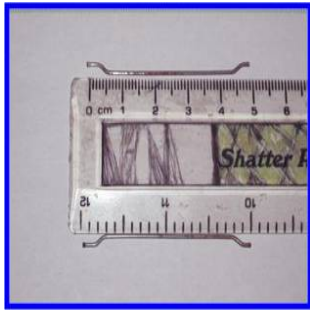
That evening whilst at home his knee felt sore and, on examination, he found a fibre protruding from the skin which he was able to remove himself. The following day however, his knee joint was stiff so he attended his local hospital where an X ray revealed another steel fibre lodged behind his knee cap. He was admitted for surgery the following day to have the fibre removed in an operation involving removal of the knee cap. As a result the employee was off work for 10 weeks.

Steel Fibre
