# Steel Fibre Penetrates Knee Cap

**READYMIX OR MORTAR PLANT**

**MANUAL HANDLING AND STORAGE**

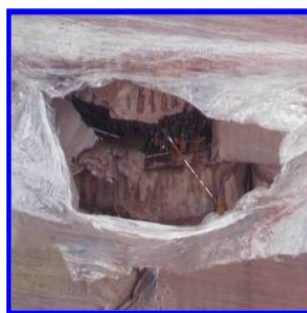
The employee had been given the task of loading truckmixers with the fibres, emptying them from cardboard boxes onto a mobile conveyor. The boxes had been stored outside on pallets under plastic covers. Due to heavy rain the boxes had become soft and were breaking down, causing the fibres to spill onto the ground.

Damaged Boxes

- Are materials stored correctly on site?
- Is housekeeping maintained to a high standard with weather conditions accounted for?
- Are tasks correctly risk assessed and Safe Systems of Work or Safe Operating Procedures developed?
- Is consideration given to individual capability and workload when planning a new activity?
- Are problems with materials and equipment reported?
- Is it ensured operatives have breaks at correct intervals, with job rotation being used as appropriate?
- Do you use the Near Miss / Hazard Alert system to highlight any potential health and safety issues?

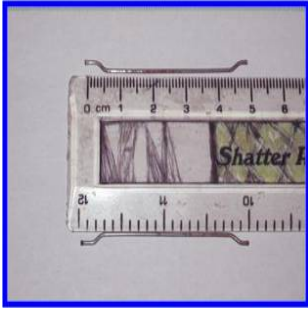
**Steel Fibre**
