# Stored Energy Incident - Resulting in a Major LIFE CHANGING Injury

**LOCATION:** ASPHALT/COATING PLANT  
**ACTIVITY:** MAINTENANCE & HOUSEKEEPING  
**SUB ACTIVITY:** N/A

**ALERT STATUS:** Normal  
**DATE ISSUED:** 02/10/2020 10:20:24  
**INCIDENT No:** 02569

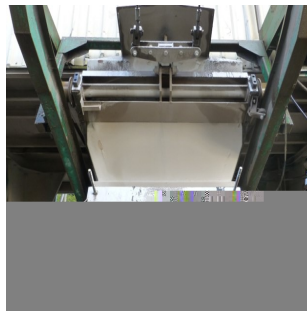
The skip door (which was under immense stored energy from the tension in the springs, in the open position) closed whilst the fitter was partially inside the door frame with such force it suspended him by the left forearm. With the task not being risk assessed and in particular how the door mechanism operated they had not established that it posed a serious risk.

- Re-enforce LOTOTO process and consider potential stored energy such as springs under tension in this case, known abnormal situation as the door being stuck open.

- Interlocked key system on the access gates had been employed, however this does not provide power isolation to other areas of the plant including the mixer, mixer doors and associated equipment directly above the skip area, which could affect any work carried out below the mixer.
