Operator injures foot while replacing the cutting edge on loading shovel bucket

ALERT STATUS: Normal
DATE ISSUED: 23/02/2021 20:21:41
INCIDENT No: 03587

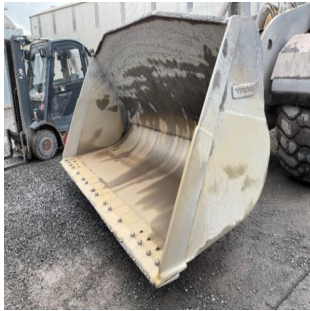
Before - Bucket showing razor sharp edge

Once the old cutting edge is removed, be aware that the base edge of a worn bucket can be very sharp NEVER run your hand or foot along the edge ALWAYS use a scraper or brush to clean the underside of the bucket, prior to fitting the new cutting edge.

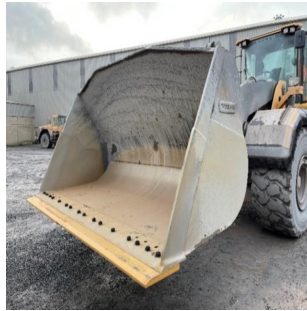
After - Bucket with new edge fitted
