Fatal 5 - Two incidents involving the delivery of concrete

LOCATION:	CONSTRUCTION/DELIVERY SITE	ALERT STATUS:	Normal
ACTIVITY:	LIFTING	DATE ISSUED:	06/07/2021 00:38:00
SUB ACTIVITY:	NO SUB ACTIVITY AVAILABLE	INCIDENT No:	03594

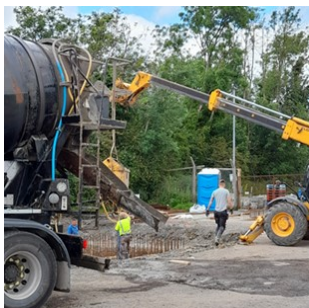
Incident 1

A mixer driver filled a concrete skip on a customer's site. A construction site operative attached a metal lifting chain to the concrete skip and then directed a plant operative to lift it with a loadall. When the skip was at a height of approx. 2m, the lifting chain snapped and the skip fell. It landed at the rear passenger side of the lorry. Fortunately, the driver had stepped away from the lifting zone. This had the potential to be very serious. The driver noted that after the incident the site personnel then lifted the skip with a worn webbed sling.

1. There was no lift plan in place - the correct lifting accessory (chain or sling) to lift the concrete skip was not planned in advance.
2. Construction site personnel did not use a lifting chain that could lift this skip safely – they may not have known the weight of the filled skip and so used a lifting chain that was not strong enough or they may not have known or understood the rating of the chain
3. The lifting chain may already have been damaged.

- Drivers must stop to assess every delivery site – if it is not safe to deliver contact your line manager or use your STOP WORK card.
- Head to toe high visibility clothing, metatarsal safety boots, hard hats, safety glasses and gloves must be worn when outside the cab.
- Always look for overhead hazards whilst on sites – this includes objects falling from scaffolding, items being lifted by plant or cranes and overhead lines. Hard hats must be worn at all times.
- Drivers and all site personnel must move to a safe area well outside the lifting zone when concrete skips and any other items are being lifted overhead.
- Drivers must not handle concrete skips. It is the responsibility of the customer to safely dispose of any unused material in concrete skips – it must not be returned to the drum of the mixer lorry.
