# Fatal 5 - Failure of wire rope on rising skip

**CONCRETE PRODUCTS PLANT**

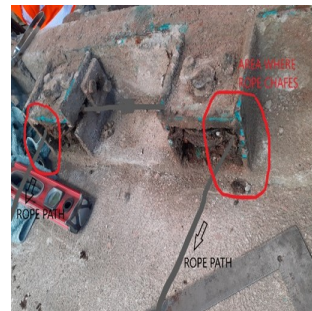
- The wire rope had been rubbing on the side of the plates housing the rope and the skip wheels.
- Over a period of time, this could have caused the rope to become damaged, hence both ropes snapping at the same time.
- Ordinarily, the design is such that should one rope fail the other will hold the skip and prevent it falling.

**Broken wire**

- Ensure a robust PPM in place for inspection and replacement of ropes within all types of manufacturing equipment, both for safety of people and production equipment.
- Ensure a Statutory Inspection undertaken for safety critical ropes
- On inspection of the ropes, check for wear due to rubbing and engineer out any problems if identified.
- Ensure a robust lubrication process is in place for ropes and wires

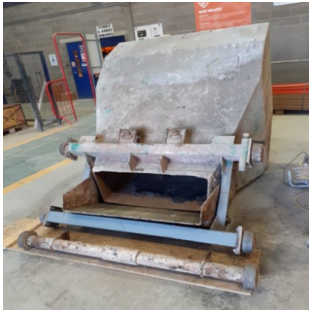
**Where the wire rope was rubbing**
