Fatal 5 - Failure of wire rope on rising skip

CONCRETE PRODUCTS PLANT
LIFTING
NO SUB ACTIVITY AVAILABLE

ALERT STATUS: Normal
DATE ISSUED: 01/02/2022 18:46:36
INCIDENT No: 03605

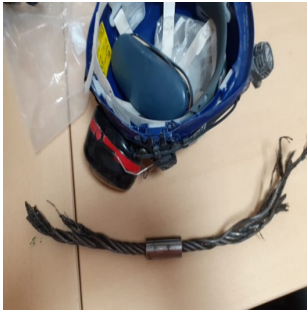
- The wire rope had been rubbing on the side of the plates housing the rope and the skip wheels.
- Over a period of time, this could have caused the rope to become damaged, hence both ropes snapping at the same time.
- Ordinarily, the design is such that should one rope fail the other will hold the skip and prevent it falling.

Broken wire

- Ensure a robust PPM in place for inspection and replacement of ropes within all types of manufacturing equipment, both for safety of people and production equipment.
- Ensure a Statutory Inspection undertaken for safety critical ropes
- On inspection of the ropes, check for wear due to rubbing and engineer out any problems if identified.
- Ensure a robust lubrication process is in place for ropes and wires
