Fatal 5 - Paver trapped by falling canopy

ALERT STATUS: Normal
DATE ISSUED: 06/04/2022 10:30:55
INCIDENT No: 03612

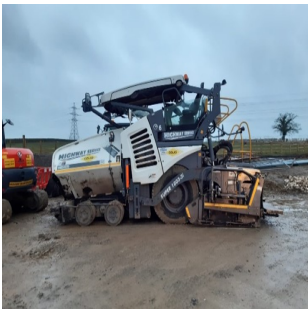
A machine operator was using a Vögele Super 1303-3i Tarmac Paving Machine to surface the road at Salden Lane. At the time of the incident, 380T of asphalt had been laid out of a planned 400T. The canopy of the paver suddenly collapsed trapping the operator under it.

Paver with collapsed canopy

- Paint the pins red so they are more visible when inserted.
- Pins and retaining clips should be fixed by chain to the canopy so they aren't lost.
- Ensure canopy pins are included in daily checks and recorded on the defect sheets
- Toolbox talk to be given on the requirement to complete all daily and weekly plant checks
- Delivery drivers must be trained on the correct procedures for loading and unloading plant.

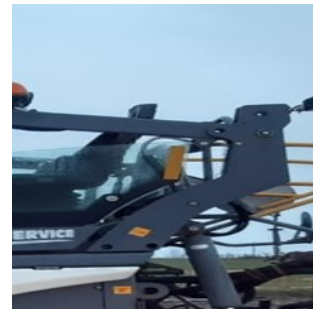
- The retaining pins for the canopy were not in place at the time of the incident and only one was found on the dashboard of the machine.
- RAM failed by bending which caused the canopy to collapse quickly
- The paver had been delivered and set up by the low loader driver

Bent ram and missing pin
