# Fatal 5 - Paver trapped by falling canopy

**ALERT STATUS:** Normal  
**DATE ISSUED:** 06/04/2022 10:30:55  
**INCIDENT No:** 03612

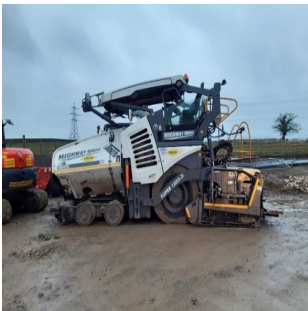
A machine operator was using a Vögele Super 1303-3i Tarmac Paving Machine to surface the road at Salden Lane. At the time of the incident, 380T of asphalt had been laid out of a planned 400T. The canopy of the paver suddenly collapsed trapping the operator under it.

- The retaining pins for the canopy were not in place at the time of the incident and only one was found on the dashboard of the machine.
- RAM failed by bending which caused the canopy to collapse quickly
- The paver had been delivered and set up by the low loader driver

Paver with collapsed canopy

- Paint the pins red so they are more visible when inserted.
- Pins and retaining clips should be fixed by chain to the canopy so they aren't lost.
- Ensure canopy pins are included in daily checks and recorded on the defect sheets
- Toolbox talk to be given on the requirement to complete all daily and weekly plant checks
- Delivery drivers must be trained on the correct procedures for loading and unloading plant.
