Delivery driver sustains amputation to finger by tail lift

LOCATION: CONSTRUCTION/DELIVERY SITE
ACTIVITY: TRANSPORT & LOGISTICS / DELIVERY
SUB ACTIVITY: DELIVERING ADMIXTURES & CHEMICALS

ALERT STATUS: Normal
DATE ISSUED: 24/05/2022 20:57:51
INCIDENT No: 03619

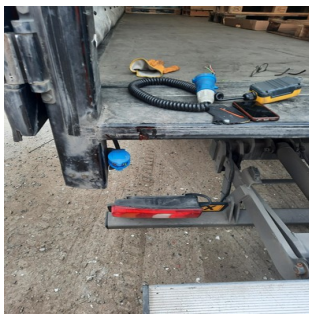
After receiving a delivery at one of our sites the delivery driver trapped their finger between the rear of their vehicle and the tail lift sustaining an amputation to their little finger.

The control cord for operating the tail lift was damaged and it is assumed that the driver was attempting to override the tail lift controls to raise the tail lift, as can be seen by the piece of wire in the socket.

Rear of lorry and tailgate lift controller

- If plant and equipment is defective, then:
 - · Stop work
 - · Quarantine the item to prevent its use
 - · Report to line manager, for item to be repaired
- Do not attempt a local fix, just to get the job done.
- Only repair plant and equipment if you are qualified and approved to undertake the repair

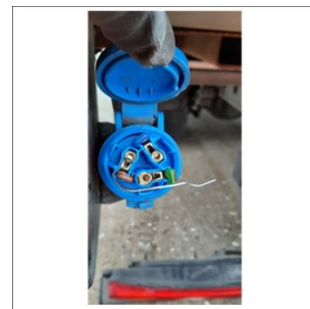
The incident was caused by the driver not following his own employer's safe system of work. This serves as a good example of how dangerous it can be to try and attempt to override a system, just to get a task complete.

Wire still in socket
