# Fatal 6 - Contract haulier rolls an artic delivering sand at a customer's site

**LOCATION:** CONSTRUCTION/DELIVERY SITE  
**ACTIVITY:** TRANSPORT & LOGISTICS / DELIVERY  
**SUB ACTIVITY:** DELIVERING AGGREGATES

**ALERT STATUS:** Normal  
**DATE ISSUED:** 23/01/2023 19:28:16  
**INCIDENT No:** 03633

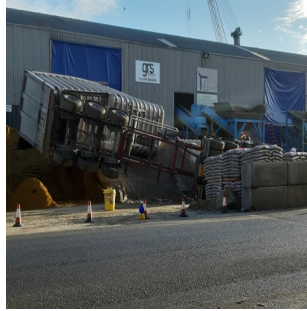
The site is a new location for the customer's business and the driver had been there approximately four times prior. The vehicle was not fitted with an inclinometer.

The sand bay is at the edge of a short bowl-shaped dip measuring between 3-5 degrees of camber adjacent to a busy port road. The artic attempted to deliver across the front of the bay, when the ram was approximately 75% extended the trailer tipped and bridged across the bay wall and the cab rolled 90 degrees onto the floor.

To unload perpendicular to the bay the cab would extend into the busy port road.

- Periodic monitoring of contracted services to check they are maintaining agreed standards is essential.
- Review the HSE guidance on vehicle handling <https://www.hse.gov.uk/workplacetransport/vehiclehandling.htm>
- Customer sites taking large volumes of materials to be jointly reviewed so safe practices can be agreed. This includes new sites or existing sites following changes that may affect our ability to deliver safely.
