Transport - Driver suffers asphalt burns to hands

LOCATION:	ASPHALT/COATING PLANT	ALERT STATUS:	Normal
ACTIVITY:	TRANSPORT & LOGISTICS / DELIVERY	DATE ISSUED:	03/07/2023 12:40:16
SUB ACTIVITY:	DELIVERING ASPHALT & HOT BOXES	INCIDENT No:	03649

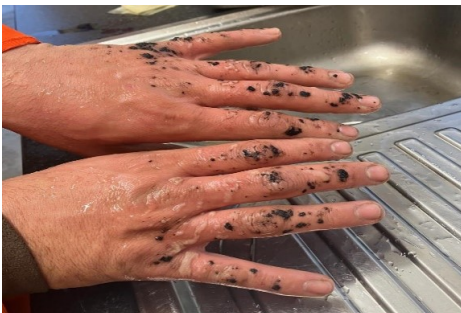
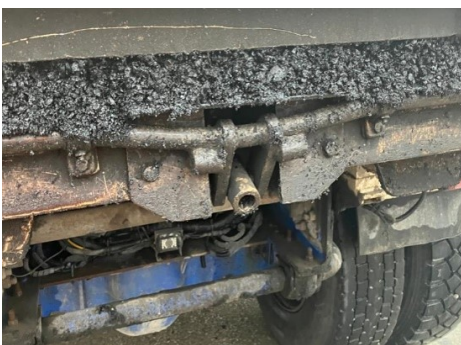
A contract tipper vehicle was overloaded with asphalt and the driver had to tip off a small amount in the designated area. After doing so, the rear door was prevented from closing by product loaded towards the back of the vehicle body. The driver used a tool / bar, which should only be used to open the tailgate if it fails to open automatically, to try and force the tailgate shut; the bar slipped and his hands momentarily came into contact with the hot asphalt below. First aid was administered on site and the driver went to hospital later in the day. He was able to carry out restricted duties the next day and returned to full driving a few days later.

Image above shows where driver inserted tool to try and close tailgate

- Vehicles are not overloaded and product isn't sitting against the tailgate.
- Ensure people are trained and competent to operate equipment.
- Wear gloves for all manual activities.
- Ensure safe systems of work are in place to include activities such as this
