# TRANSPORT - Fatal 6 - Concrete mixer loss of drum

## WHAT HAPPENED

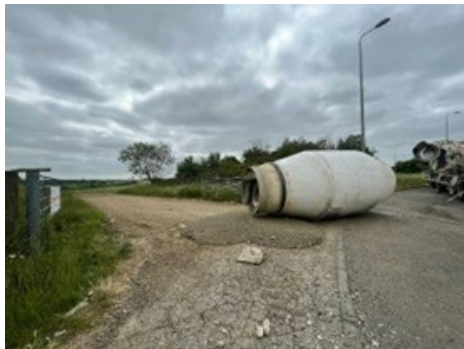
In June 2023 a third party owned concrete truck mixer was making a delivery, the vehicle suffered a significant structural failure of the mixer chassis/A frame. The failure resulted in the mixer drum becoming detached from the vehicle and coming to rest at the side of the carriageway.

- A forensic examination of the truck was completed by independent specialist technicians who concluded that:
  - The concrete mixer sub-frame snapped suddenly.

- The failure initially occurred at a weakness in the sub-chassis which had been previously welded for a repair in 2019.
  - The weld had been carried out by a previous owner and not highlighted to the current haulier.

- The weld had weakened over time and eventually failed resulting in the incident.

- Immediately after the incident all the truck fleet dedicated to a major project were inspected, initially by their drivers/haulier and then by vehicle mechanics to confirm similar defects were not present.

- The remainder of the RMX fleet has been visually inspected by the company's transport team checking mixer bodies and their chassis for visual signs of cracking or deterioration.

- Operators should ensure that daily driver pre-start check sheets specifically include key structural areas like the A frame chassis.
- McFee have agreed to digitise their operator's manual and will issue QR codes, to be fixed to mixers they have manufactured, which will enable anyone to access the latest operator's manual.

- All hauliers must inform their service providers to carry out a thorough inspection of mixer drums, bodies, and chassis by a competent mechanic on their vehicles at the next 6 weekly safety inspection.

- Any repair work carried out to mixer bodies, or indeed elsewhere on the truck, should be listed & passed on to future owners so as correct focus can be given to potential future weak spots.
