# 3 recent high potential incidents involving underground cable strikes

<b>LOCATION:</b>	<b>CONSTRUCTION/DELIVERY SITE</b>	<b>ALERT STATUS:</b>	<b>High Potential</b>
<b>ACTIVITY:</b>	<b>CONTRACTING</b>	<b>DATE ISSUED:</b>	<b>29/11/2023 11:00:49</b>
<b>SUB ACTIVITY:</b>	<b>NO SUB ACTIVITY AVAILABLE</b>	<b>INCIDENT No:</b>	<b>03679</b>

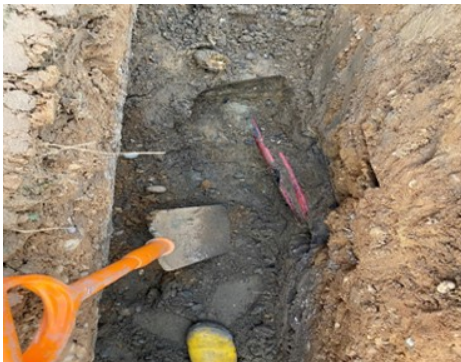
In the other two cases, cables were identified by the CAT scans and were initially located by hand digging with insulated tools

- First incident the CAT scan had identified an earthing cable, but not the HV cable below, which was struck when the trenching works continued with an excavator.
- Second incident, the operator decided to expose the cable at a second point using his machine, striking the cable, in contravention of the RAMS and PtW.

- Correct use of Cable Avoidance Tools, in one case the tool was only used in "Power" mode, restricting its sensitivity.
- Compliance with RAMS, exposing cables at crossing points by hand
- More explicit "Permit to Dig" process with none working supervision in place.
- Additional heavier duty marking of buried services during installation.
