Fatal 1 - Socomec safety isolator - operator found he was able to remove padlock whilst isolated

LOCATION:	ASPHALT/COATING PLANT	ALERT STATUS:	High Potential
ACTIVITY:	GUARDING AND ISOLATION	DATE ISSUED:	16/01/2024 13:55:49
SUB ACTIVITY:	NO SUB ACTIVITY AVAILABLE	INCIDENT No:	03690

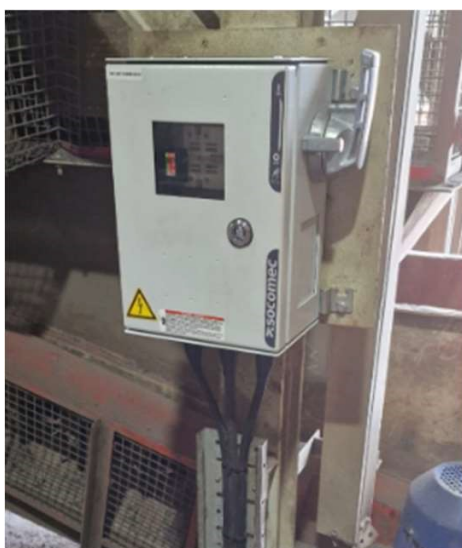
Whilst trying out an isolation at an asphalt plant during a major regeneration project, a new Socomec safety enclosure isolator was discovered to be faulty, meaning the locked padlock could be removed whilst the system was isolated.

An asphalt plant engineer discovered whilst 'trying out' his isolation, that it was possible to remove his locked padlock from the isolator by depressing the handle past its 'OFF' position.

- With immediate effect, it instructed all unit managers to investigate, by trial, whether they can depress their Socomec isolators handles far enough to slip the padlock off. A padlock must be applied, and physical trial undertaken.
- A sign off sheet must be provided stating the isolator name, date, time and the result of the test.
- Any isolator found to be faulty will be marked using defective equipment documentation and a plan put in place to rectify the problem.
- Contact will be made with the OEM to find permanent solution.
