# FATAL 5 - Operative sustains impact to chest when struck by a manifold during a crane lift

LOCATION: QUARRY  
ACTIVITY: LIFTING  
SUB ACTIVITY: NO SUB ACTIVITY AVAILABLE

ALERT STATUS: High Potential  
DATE ISSUED: 22/02/2024 18:43:33  
INCIDENT No: 03697

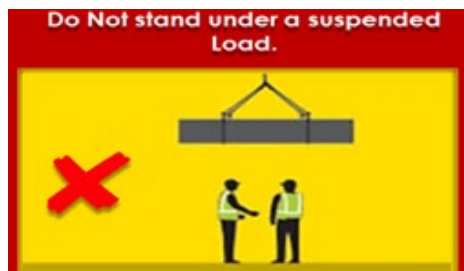
During the lift the manifold became caught on a protruding bolt, the maintenance operative approached and levered the manifold off whilst the load was still in tensions in 'lift'. When the load was freed, it swung back and struck the IP who suffered bruising to their ribs. Click on additional pdf to see summary of this alert.

1. Clear assessment of the hazards must be completed prior to any job, all parties involved must discuss and agree, then sign the risk assessment and method statement.
2. Exclusion zones to be maintained to only allow designated crane team into the lifting area.
3. For further information on lifting please follow this link to the HSE web page on lifting <https://www.hse.gov.uk/construction/safetytopics/lifting-operations.htm>
4. Please see below examples of signage that could be used in area where a lifting operation is taking place

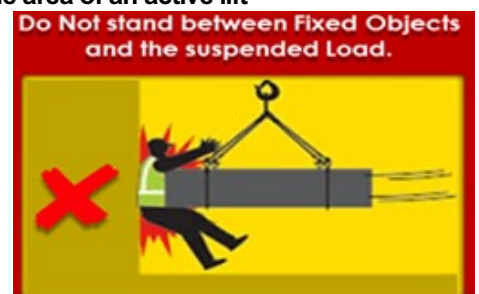
A maintenance operative was struck by a manifold whilst it was being lifted by a crane to allow access to the screen deck.

Never enter the area of an active lift
