Fatal 5 - Readymix discharge cone and frame weighing 350 kg fall during cleaning operation due to mechanical failure

LOCATION:	READYMIX OR MORTAR PLANT	ALERT STATUS:	High Potential
ACTIVITY:	LIFTING	DATE ISSUED:	14/03/2024 17:04:45
SUB ACTIVITY:	NO SUB ACTIVITY AVAILABLE	INCIDENT No:	03700

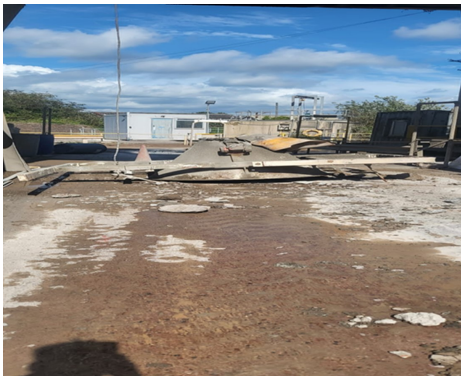
He had walked away to get tools to clean the cone when he heard a loud crash. He returned to the loading area to find the frame and discharge cone had fallen to the ground; it is estimated that the combined weight of the assembly was 350kg.

Initial investigations indicate that the split pins had sheared off the pivot point, combined with possible distortion in the frame, which allowed movement and the frame to detach from the pivot point. Fortunately, the Plant Manager was not in the line of fire when the failure occurred. Image below shows discharge cone and lifting frame on the ground.

Preventative maintenance - It is believed the split pins on the pivot end of the frame had sheared off through wear and tear and regular lowering of the frame assembly.

- Ensure maintenance regimes are effective and all load bearing parts of equipment such as pivot hinges are subject to routine inspections in accordance with manufacturer’s specification.
- Split pins must be checked for wear to ensure equipment remains in alignment.

- Consider installation of secondary safety chains with adequate Safe Working Load on the pivot sides of similar plants with a winch operated loading chute.
- Ensure plants are operated in strict accordance with manufacturer’s guidelines.
- Ensure winches and fixing points are subject to required statutory inspection regimes.
- Are preventative maintenance regimes effective in highlighting defects to critical components?
- Control access to areas ensuring operators are not in the ‘line of fire’ when operating plant/equipment, consider exclusion zones/barriers.
- Do we ensure people STOP & THINK/Take-5 before completing tasks?

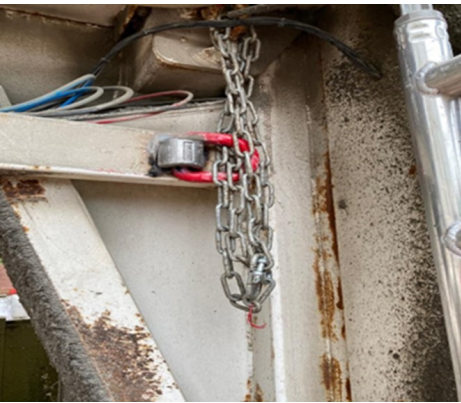
Image below shows heavy duty safety chains retrofitted to the pivot point on the lifting assembly.
