# Fatal 3 - TRANSPORT - Contractor falls from cab and injures his head

<b>LOCATION:</b>	<b>QUARRY</b>	<b>ALERT STATUS:</b>	<b>Normal</b>
<b>ACTIVITY:</b>	<b>ACCESS &amp; EGRESS &amp; WORKING AT HEIGHT</b>	<b>DATE ISSUED:</b>	<b>20/03/2024 14:28:06</b>
<b>SUB ACTIVITY:</b>	<b>N/A</b>	<b>INCIDENT No:</b>	<b>03702</b>

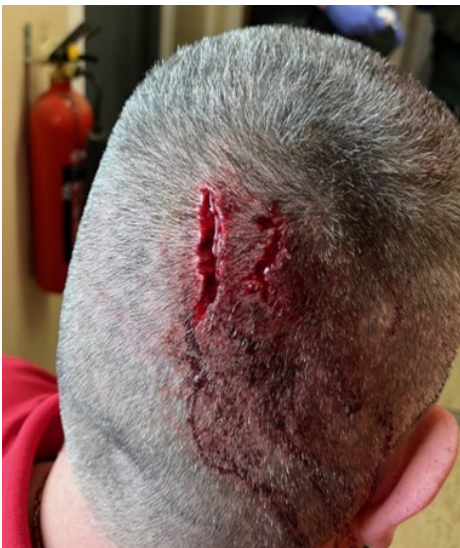
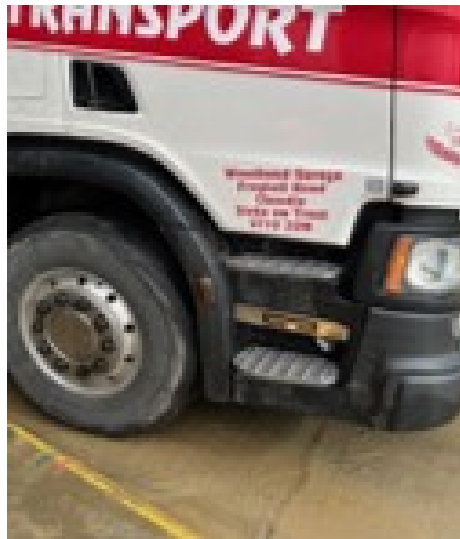
A contract haulage driver parked on site in preparation for loading of material. On exiting his vehicle cab, he misjudged his footing and missed the bottom step. He fell, striking his head, right elbow and lower back on the concrete paving. He received first aid treatment on site and his condition was monitored. He reported feeling dizzy and sick and therefore the Emergency Services were called. An ambulance arrived and the driver was taken to hospital for assessment, accompanied by the Plant Manager. He was released later in the day having had stitches to close his head wound.

**Vehicle** - The driver was familiar with the cab step configuration, it being his regular vehicle.

**Housekeeping** - Housekeeping in the area was exceptional, with steps / curbs clearly highlighted.

- Eliminate / reduce the need for drivers to get out of their cabs.
- Driver concentration, ensure 3 points of contact are maintained when getting in / out of vehicles.
- Footwear should be in good condition and worn correctly, laces fully tied.

- Assess if we can reduce the need for drivers to get out of their cabs through systems and engineering improvements.
- Review Risk Assessments and Safe Systems of Work (SSOW) relating to drivers' PPE and ensure all drivers are aware of the PPE requirements.
- Confirm all drivers receive and understand the requirements of updated SSOW.

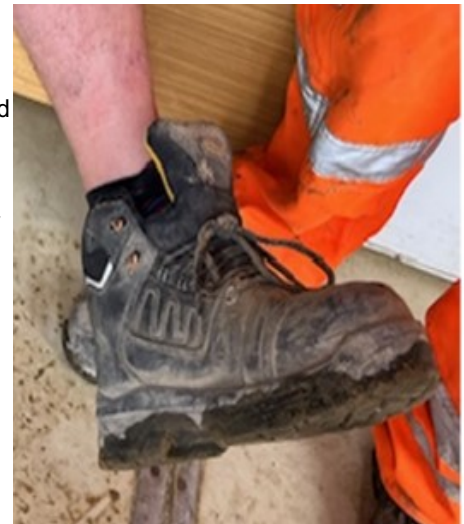
**PPE** - Although the driver was wearing boots they were not fastened correctly (see photo).
