Fatal 3- Potential fall from height when operator undertaking cleaning operation

LOCATION: AGGREGATE DREDGER
ACTIVITY: ACCESS & EGRESS & WORKING AT HEIGHT
SUB ACTIVITY: N/A

ALERT STATUS: High Potential
DATE ISSUED: 15/04/2024 20:51:51
INCIDENT No: 03705

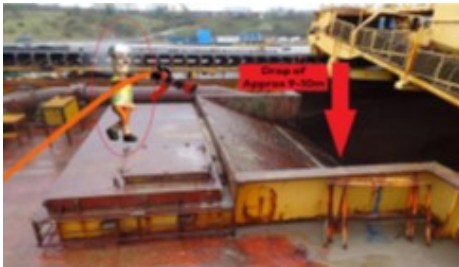
Following cargo discharge of a marine aggregate's dredger, an employee was detailed to washdown the hopper's forward slope with a fire hose. The employee stood on a raised hatch cover, close to an unprotected edge with a significant fall from height potential. Another employee noticed this action and stepped in, explaining the danger. The work was then completed from the well deck (same area but lower as not on the hatch), affording protection due to a ledge.

Image below shows the position of operator on hatch lid

- By completing the task from an alternative area with sufficient edge protection in place to reduce fall from height potential.
- The washdown method has now been adjusted where it is now completed from the sides where a handrail guard exists, and additional handrails are left in situ.
- Periodic reviews of tasks / processes, including those considered low risk, to ensure all hazards / risks have been identified and controlled.
- Avoid complacency especially during ‘routine tasks’

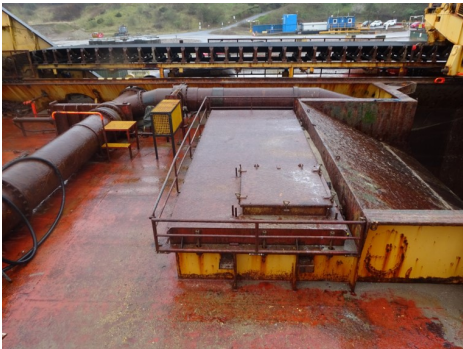
Image below shows additional handrails
