# Fatal 3- Potential fall from height when operator undertaking cleaning operation

LOCATION: AGGREGATE DREDGER  
ACTIVITY: ACCESS & EGRESS & WORKING AT HEIGHT  
SUB ACTIVITY: N/A

**ALERT STATUS:** High Potential  
**DATE ISSUED:** 15/04/2024 20:51:51  
**INCIDENT No:** 03705

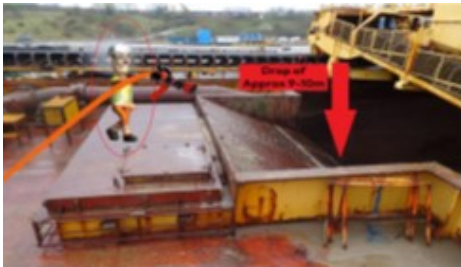
Following cargo discharge of a marine aggregate's dredger, an employee was detailed to washdown the hopper's forward slope with a fire hose. The employee stood on a raised hatch cover, close to an unprotected edge with a significant fall from height potential. Another employee noticed this action and stepped in, explaining the danger. The work was then completed from the well deck (same area but lower as not on the hatch), affording protection due to a ledge.

Image below shows the position of operator on hatch lid

- **Safe Systems** - No work instruction, Risk Assessment or safe system of work existed for the task
- **Risk Perception** - Perception for the task was of trivial risk by employee and supervisors.
- **Take - 5** - No Point of work risk assessment/TAKE-5) had been completed prior to the task.
- **Process** - The task was considered 'routine' and had been completed on many previous occasions, this may have led to complacency regarding the associated risk.

- By completing the task from an alternative area with sufficient edge protection in place to reduce fall from height potential.
- The washdown method has now been adjusted where it is now completed from the sides where a handrail guard exists, and additional handrails are left in situ.
- Periodic reviews of tasks / processes, including those considered low risk, to ensure all hazards / risks have been identified and controlled.
- Avoid complacency especially during 'routine tasks'

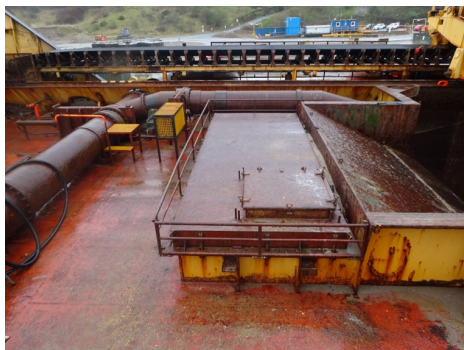
Image below shows additional handrails
