# Fatal 1 – Isolation failure - Operative cleaning in banding zone was able to enter the adjacent bagging zone.

**LOCATION:** CONCRETE PRODUCTS PLANT  
**ACTIVITY:** GUARDING AND ISOLATION  
**SUB ACTIVITY:** NO SUB ACTIVITY AVAILABLE

**ALERT STATUS:** High Potential  
**DATE ISSUED:** 02/05/2024 15:56:09  
**INCIDENT No:** 03707

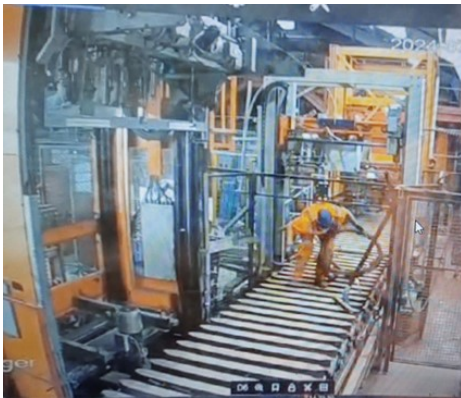
An operative was cleaning in the block plant packaging line using a vacuum cleaner. The operative had followed LOTOTO and was cleaning the bander area. The operative was then able to take the tooling and himself from one zonal area to another as the tunnel through the enclosure guarding was not obstructed by a pack of blocks as it would usually be. The operative activated a sensor in the bagging zone which allowed the bagging machine to activate and the bagger frame to drive forward over the conveyor. The bagger then stayed in position over the conveyor awaiting the next sequential signals to lower. The frame did not lower, and no injuries occurred.

Image below shows operator in the Bander Zone, the bagging zone is in the front of the picture.

- Ensure guarding is effective at all times and can stop persons entering into different zonal areas.
- Product is not to be relied on as guarding between zones.
- Ensure all procedures for isolation and work instructions are effective and all employees have been appropriately.
- Further Information – [MPA Guide to Energy Isolation & LOTOTO](#)
- For more information on isolation please go the Fatal 1 section on the [Safequarry website](#)

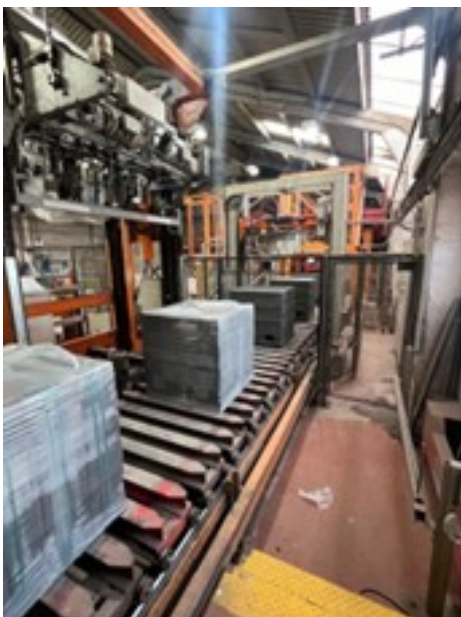
This image shows how the normal production line pack positions prevents passage between different equipment zones.
