# Fatal 1 – Isolation failure - Operative cleaning in banding zone was able to enter the adjacent bagging zone.

<b>LOCATION:</b>	<b>CONCRETE PRODUCTS PLANT</b>	<b>ALERT STATUS:</b>	<b>High Potential</b>
<b>ACTIVITY:</b>	<b>GUARDING AND ISOLATION</b>	<b>DATE ISSUED:</b>	<b>02/05/2024 15:56:09</b>
<b>SUB ACTIVITY:</b>	<b>NO SUB ACTIVITY AVAILABLE</b>	<b>INCIDENT No:</b>	<b>03707</b>

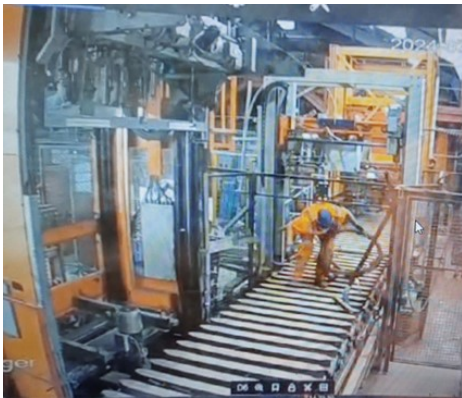
An operative was cleaning in the block plant packaging line using a vacuum cleaner. The operative had followed LOTOTO and was cleaning the bander area. The operative was then able to take the tooling and himself from one zonal area to another as the tunnel through the enclosure guarding was not obstructed by a pack of blocks as it would usually be. The operative activated a sensor in the bagging zone which allowed the bagging machine to activate and the bagger frame to drive forward over the conveyor. The bagger then stayed in position over the conveyor awaiting the next sequential signals to lower. The frame did not lower, and no injuries occurred.

Image below shows operator in the Bander Zone, the bagging zone is in the front of the picture.

- Ensure guarding is effective at all times and can stop persons entering into different zonal areas.
- Product is not to be relied on as guarding between zones.
- Ensure all procedures for isolation and work instructions are effective and all employees have been appropriately.
- Further Information – [MPA Guide to Energy Isolation & LOTOTO](#)
- For more information on isolation please go the Fatal 1 section on the [Safequarry website](#)

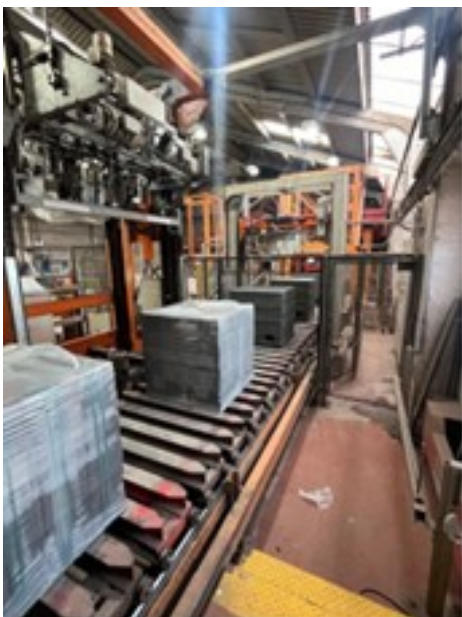
This image shows how the normal production line pack positions prevents passage between different equipment zones.
