# Fatal 3 - Operator falls and fractures skull whilst dismounting from a wheeled loading shovel

**LOCATION:** QUARRY  
**ACTIVITY:** ACCESS & EGRESS & WORKING AT HEIGHT  
**SUB ACTIVITY:** N/A

**ALERT STATUS:** Normal  
**DATE ISSUED:** 28/05/2024 16:16:40  
**INCIDENT No:** 03710

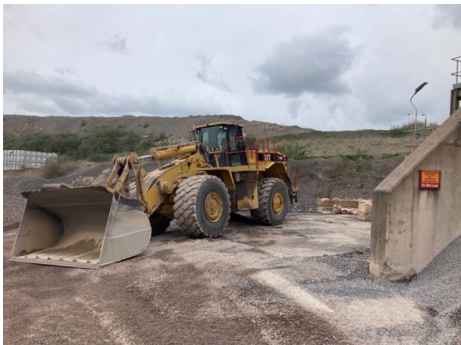
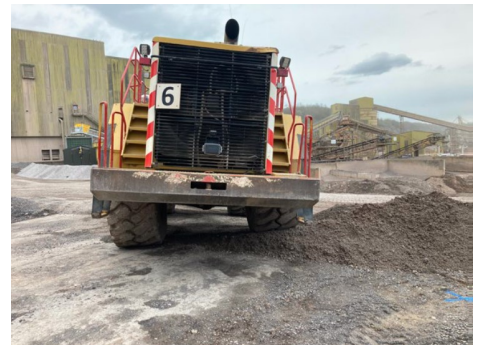
On flat ground, the distance from the top of the bottom ladder rung on the loading shovel is 58cm. At the time of the incident, due to the surface conditions where the loading shovel was parked, it was tilting, the right-hand was at 60cm, and the left-hand side was 80cm from the ground.

- Insufficient housekeeping in the area of the parked vehicle.
- The operator failed to sufficiently undertake a dynamic risk assessment prior to exiting the vehicle.

The images below show the position of the loading shovel

- Review and implement the site 5S process.
- Discuss the incident with all staff on-site, focusing on positioning of equipment, use of dynamic and point of work risk assessments.
