Fatal 1 - Operative working in guarded area without following LOTOTO procedure (bypassing safety system)

LOCATION: CONCRETE PRODUCTS PLANT
ACTIVITY: GUARDING AND ISOLATION
SUB ACTIVITY: NO SUB ACTIVITY AVAILABLE

ALERT STATUS: High Potential
DATE ISSUED: 28/05/2024 16:23:18
INCIDENT No: 03711

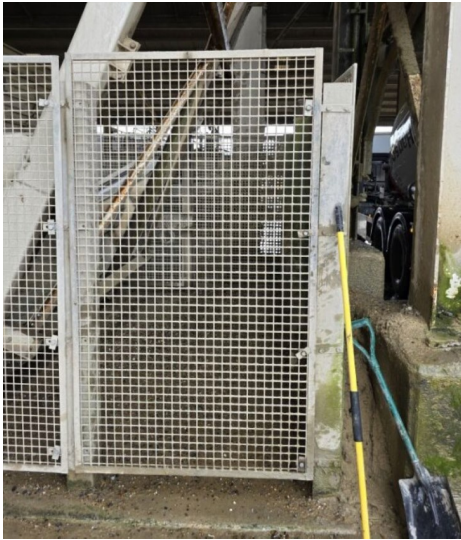
The plant supervisor at a concrete plant independently violated UKCP62 protocols by entering a guarded area to clean spillage, whilst the skip was still fully functional. Ignoring personal safety risks, they procured tools, unlocked a securely bolted hinged guard/panel, and proceeded to clear the spillage beneath the operational skip. Images below show the potential risk the operator was exposed to if the skip had become operational.

- Breaching UKCP62 Isolation and Lockout Procedure, and not following LOTOTO Training requirements.

Below is an image of the securely bolted hinged guard that was used to bypass the Castell key exchange gate.

- UK communications to be developed to share learnings
- Develop and roll out a UK wide safety video ‘I could have saved a life that day but chose to look the other way’
- Proposal for bolt heads to be welded so they can only be removed from inside the interlocked guarded area to be shared with the projects team

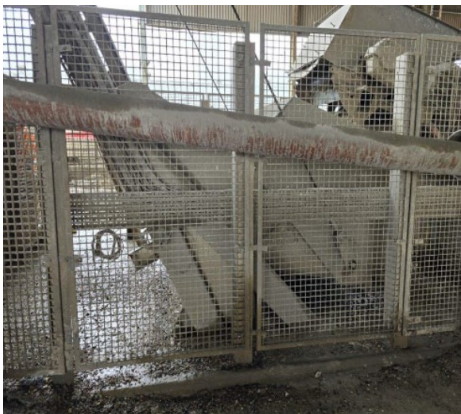
This a reverse view but showing the skip in its down position.

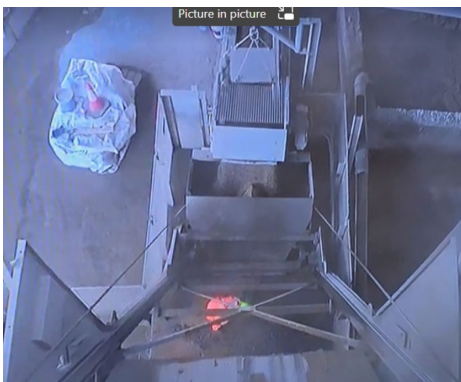
The final image shows the operator working in the skip area, the entrance gate in the top left of the image should have been used. The open gate behind the operator is how the operator gained entry.
