# **Fatal 1 - Operative working in guarded area without following LOTOTO procedure (bypassing safety system)**

**LOCATION:** CONCRETE PRODUCTS PLANT  
**ACTIVITY:** GUARDING AND ISOLATION  
**SUB ACTIVITY:** NO SUB ACTIVITY AVAILABLE

**ALERT STATUS:** High Potential  
**DATE ISSUED:** 28/05/2024 16:23:18  
**INCIDENT No:** 03711

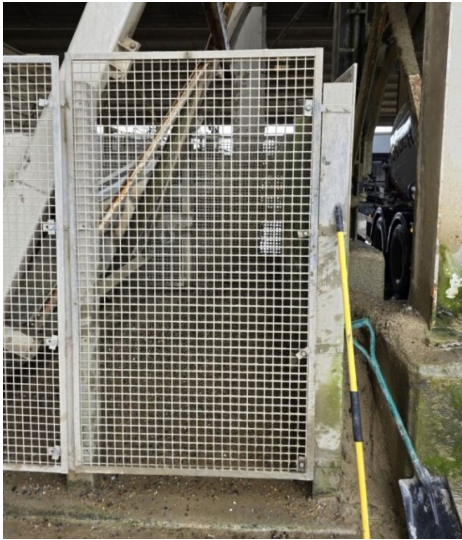
The plant supervisor at a concrete plant independently violated UKCP62 protocols by entering a guarded area to clean spillage, whilst the skip was still fully functional. Ignoring personal safety risks, they procured tools, unlocked a securely bolted hinged guard/panel, and proceeded to clear the spillage beneath the operational skip. Images below show the potential risk the operator was exposed to if the skip had become operational.

- Breaching UKCP62 Isolation and Lockout Procedure, and not following LOTOTO Training requirements.

Below is an image of the securely bolted hinged guard that was used to bypass the Castell key exchange gate.

- UK communications to be developed to share learnings
- Develop and roll out a UK wide safety video 'I could have saved a life that day but chose to look the other way'
- Proposal for bolt heads to be welded so they can only be removed from inside the interlocked guarded area to be shared with the projects team

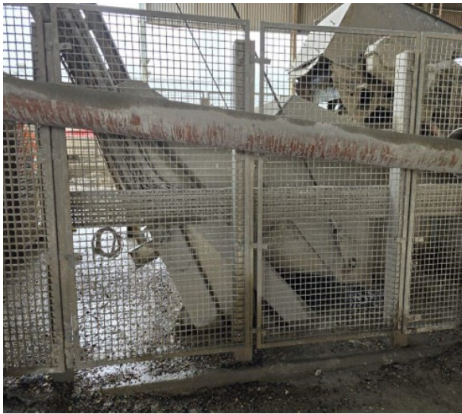
This a reverse view but showing the skip in its down position.

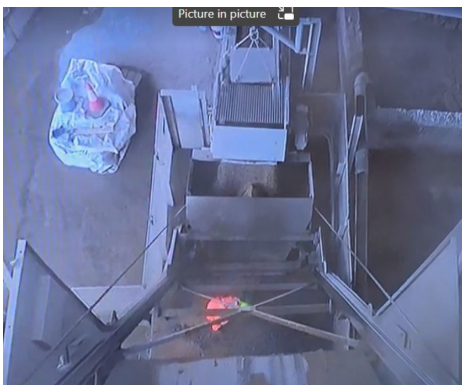
The final image shows the operator working in the skip area, the entrance gate in the top left of the image should have been used. The open gate behind the operator is how the operator gained entry.
