FATAL 2 – TRANSPORT - Front-end loader collides with 4x4 whilst reversing in quarry

LOCATION: QUARRY
ACTIVITY: PEDESTRIAN AND TRANSPORT SAFETY ON-SITE
SUB ACTIVITY: NO SUB ACTIVITY AVAILABLE

ALERT STATUS: High Potential
DATE ISSUED: 24/06/2024 15:25:36
INCIDENT No: 03720

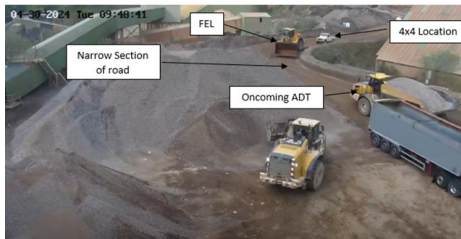
The FEL was being followed by a Land Rover through the processing area. As the FEL approached a narrow roadway, it had stopped rapidly to avoid collision with an oncoming articulated dump truck (ADT).

To create space for the ADT, the FEL reversed, however the location of the 4x4 was unknown to the FEL driver. The FEL collided with the 4x4, causing significant damage to the front of the vehicle. Fortunately, nobody was injured.

The image below was taken from the CCTV footage at the site.

- Ensure all your heavy mobile equipment (HME) and light vehicle operators are carrying out daily inspections on their vehicles.
- Any safety critical defects which may affect the safety of operating their machines at any time must be reported immediately.
- Undertake a toolbox talk on the safe operating distances for mobile plant and check all light vehicle operators are aware of leaving a minimum 15m safe distance between an HME and their vehicle when operating on site
- Ensure all operators communicate using radios or site agreed signals when operating in close proximity to one another.
- Ensure all aspects of your work place transport policies are completed with a valid and up to date traffic management plan.

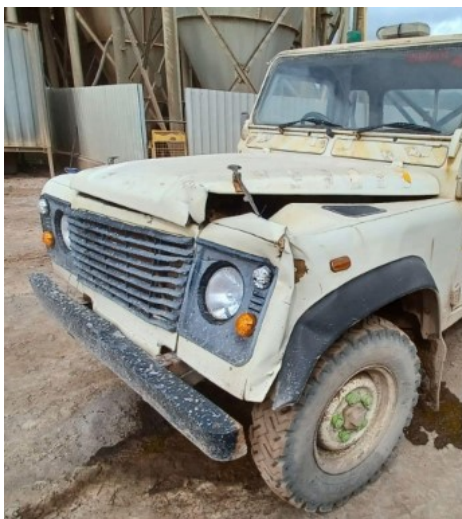
The damage to the front left passenger-side is shown in the image below.
