Fatal 1 - Contractor exposed himself to risk of being seriously injured in crusher by failing to follow procedures

LOCATION: QUARRY
ACTIVITY: PRODUCTION AND PROCESSING
SUB ACTIVITY: AGGREGATE PROCESSING

ALERT STATUS: High Potential
DATE ISSUED: 05/08/2024 16:25:16
INCIDENT No: 03728

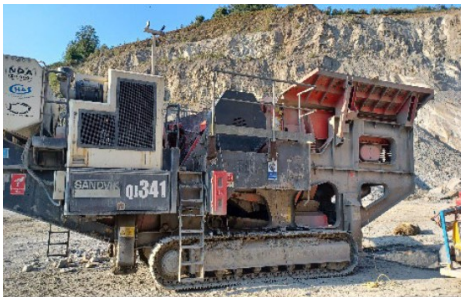
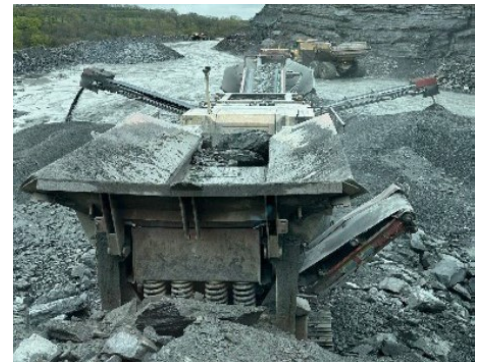
A contractor plant operator (agency labour) was found above the mobile crusher jaws attempting to clear bridged material. They had left the designated walkway, climbed over the handrails and had not implemented LOTOTO. The machine was running, the crusher jaws were turned off but the engine and conveyor were still operating.

- The worker did not follow the communication process as required by the Risk Assessment and Method Statement (RAMS)
- The worker was prepared to defeat the provided access restriction when they climbed over rails to access the mobile crushing area
- The worker was prepared to deviate from instruction and take action even though they knew they were not authorised.

- Review Task Authorisation process
- Review incident scene management
- More disciplined approach to maintaining contractor induction records
- Review site RAMS – including best practice
- Share report with agency

- Check task authorisation for long term contractors ([see MPA Guidance on Safequarry](#))
- National Ops meeting to discuss the standardisation of contractor management post incident where non-compliance is identified
- Review site safety meeting frequency and improve quality of record keeping
- National Ops meeting to discuss review of high hazard RAMS in line with 'The Fatal 6'
