# Fatal 1 - Contractor exposed himself to risk of being seriously injured in crusher by failing to follow procedures

QUARRY

AGGREGATE PROCESSING

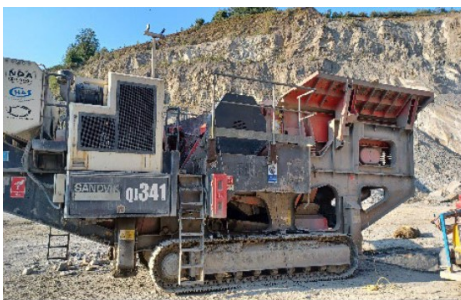
A contractor plant operator (agency labour) was found above the mobile crusher jaws attempting to clear bridged material. They had left the designated walkway, climbed over the handrails and had not implemented LOTOTO. The machine was running, the crusher jaws were turned off but the engine and conveyor were still operating.

- The worker did not follow the communication process as required by the Risk Assessment and Method Statement (RAMS)
- The worker was prepared to defeat the provided access restriction when they climbed over rails to access the mobile crushing area
- The worker was prepared to deviate from instruction and take action even though they knew they were not authorised.

- Review Task Authorisation process
- Review incident scene management
- More disciplined approach to maintaining contractor induction records
- Review site RAMS – including best practice
- Share report with agency

- Check task authorisation for long term contractors ([see MPA Guidance on Safequarry](#))
- National Ops meeting to discuss the standardisation of contractor management post incident where non-compliance is identified
- Review site safety meeting frequency and improve quality of record keeping
- National Ops meeting to discuss review of high hazard RAMS in line with 'The Fatal 6'
