# Transport - Tipper driver injures leg when walking into Armco barrier

LOCATION:	READYMIX OR MORTAR PLANT	ALERT STATUS:	Normal
ACTIVITY:	TRANSPORT & LOGISTICS / DELIVERY	DATE ISSUED:	27/08/2024 12:20:26
SUB ACTIVITY:	DELIVERING AGGREGATES	INCIDENT No:	03730

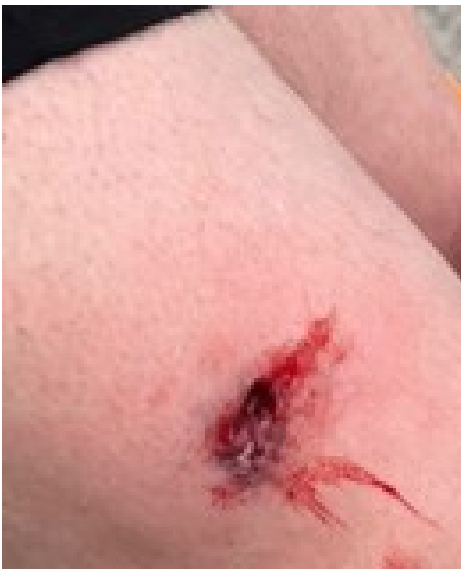
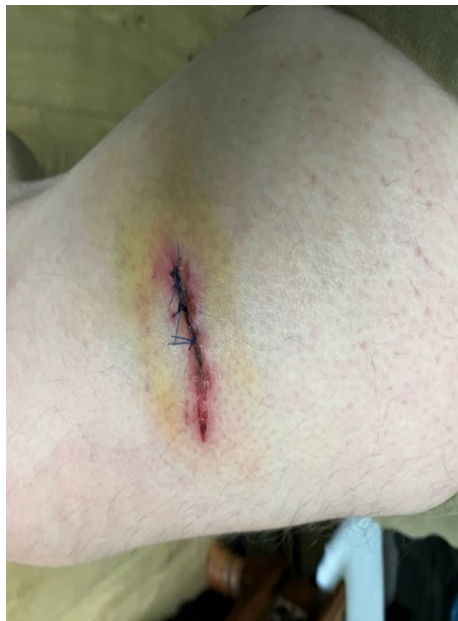
The discharge hopper capacity is 10 tonne, therefore the delivery per vehicle is made up of several tips. Unfortunately, because the hopper is below ground, the level of material in the hopper could not be seen in the vehicle's rear camera therefore, the driver needed to get out and check the level. When the driver was returning to the vehicle cab he deviated off the usual route and walked into the end of a barrier which protects the control panel for the transverse conveyor.

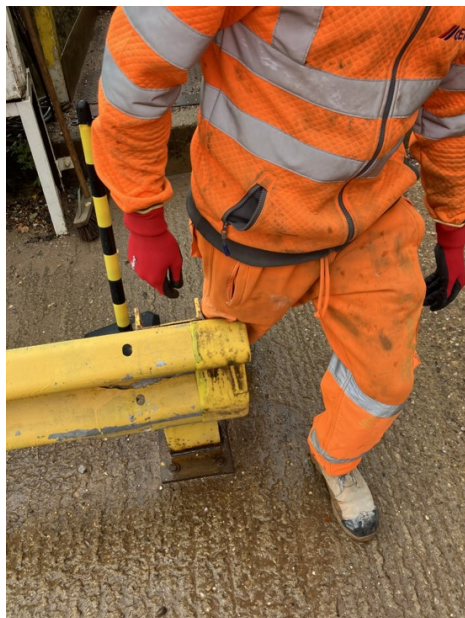
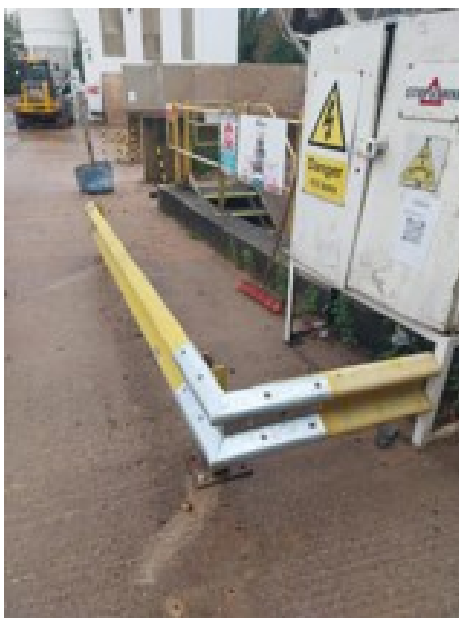
The exposed end of the Armco barrier was not protected. See below the before and after images, these show how a similar incident will be avoided by the changes made after this incident.

The driver didn't carry out a 'Take 5' assessment before delivering. If he had, he may have noticed the barrier and taken extra care around this area and highlighted the hazard via a Near Miss / Hazard Alert card.

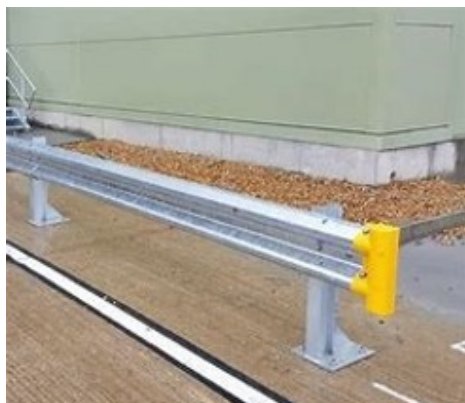
- Wherever possible, eliminate the need for driver / pedestrian movement on sites.
- Risk assess pedestrian areas for hazards such as slips, trips and falls, sharp edges, and unprotected pedestrian areas.
- Review pedestrian barriers to ensure there are no exposed sharp edges, for example by using end caps on Armco barriers, see image below.
