Overhead Hoist Incident

WHAT HAPPENED

QUARRY

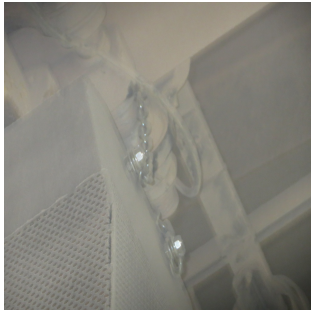
Safety chain and new box fitted.

Fit safety chains supplied by the providers to all chain boxes on overhead hoists.
