Driver Struck By Falling Wall

CONCRETE PRODUCTS PLANT
TRANSPORT & LOGISTICS / DELIVERY
MOBILE PLANT

ALERT STATUS: Normal
DATE ISSUED: 23/06/2014
INCIDENT No: 00383

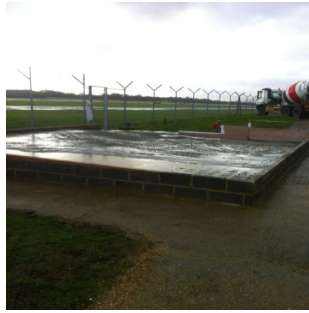
He had finished discharging the load and was preparing to wash down his truck chutes into an adjacent area of the slab as directed, when the concrete block wall collapsed and fell against his leg, knocking him over, trapping his right leg and causing him to knock his head against his truck's access ladder. The IHC was not wearing a hard hat.

The wall had collapsed in time with the raking motion of the site person who was leveling the slab. The IHC sustained a cut to his forehead, minor concrete burns to his arm and a more serious cut to his right shin which meant he was detained in hospital for 5 days and required a skin graft.

Scene of Incident

- The driver was not wearing his safety helmet whilst on site. Do all employees and contractors on site comply with company minimum personal protective equipment (PPE) standards? Are checks made during induction and site tours?
- No checks had been made to ensure drivers were complying with company standards or the customer site rules for the contract. Indeed there did not appear to be any communication between the site and plant and/or drivers regarding site conditions? Are post delivery service audits undertaken that include reference to IHC site safety?
- The driver had previously been trained in MYSPACE and had attended this year's back to work training. Are there systems in place to ensure that drivers attend training sessions and receive refresher training at appropriate intervals?
- The driver considered the wall construction as suspect but had still put himself between his truck

and the wall. Are drivers aware that they must report unsafe conditions and behaviours immediately? Do they consider their colleagues delivering to the same site? Is the near miss / hazard alert card system used by all personnel, including drivers? (MYSPACE is an initiative to encourage drivers to undertake a dynamic risk assessment, considering who/what can enter the area around their vehicle and the resulting risks).

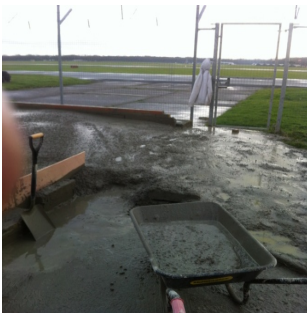
Spillage when wall collapsed
