# Fitter Struck by Grinding Wheel

## WHAT HAPPENED

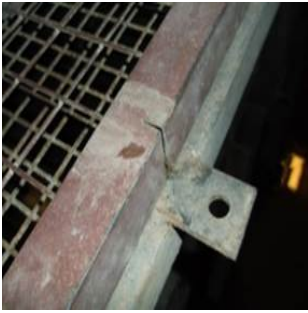
The Fitter then proceeded to cut into the guard with a hand held grinder, complete with a "thin" cutting disc, while the Manager held onto the guard at the opposite side. At approximately 1/3rd through the cut, the disc jammed, which caused the tool to shoot out of the Fitter's hands, hitting his left leg before falling to the floor; since it was not fitted with a hold to run switch, the grinder was still running.

Guarding Being Cut

- The guard was not clamped securely and moved when the grinder was applied. Are there suitable maintenance facilities on site for the range of activities being undertaken? Are work pieces suitably supported / secure, being clamped or held in a vice where possible?
- Though having received training, the Fitter was using the wrong disc for the activity being undertaken. Are personnel trained, competent and authorised for the full range of tasks they are required to carry out? Do they apply this training in the use and selection of the work methods and equipment they use?
- The Site Manager was positioned in a potential danger zone. Do we enforce exclusion zones where there is a risk of being struck by moving / flying / falling objects?

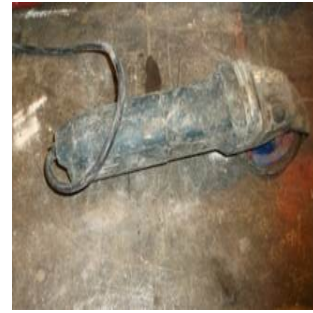
Angle Grinder

maintained, tools / equipment for the job and never make do? Do you have adequate defect reporting and inspection systems for tools and machinery? Do powered hand tools have hold to run controls that cut the power when released?

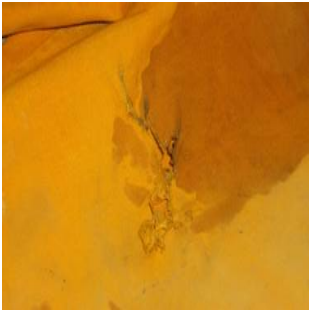
This caused a cut to the Fitter's leg which required hospital attention and six stitches. The Fitter had completed a pre-job Worksafe Assessment prior to the task.

**Fitters Overalls**
