# Truck Wheel Loss

ALERT STATUS: Normal  
DATE ISSUED: 23/02/2015 12:15:58  
INCIDENT No: 00402

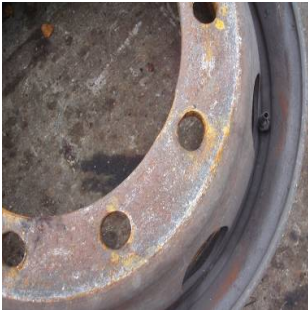
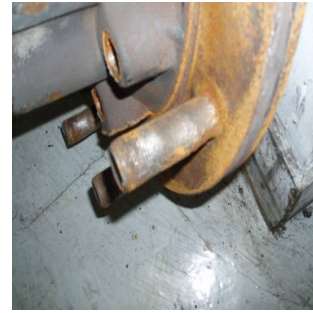
Recently, an articulated lorry lost a wheel on the M45 motorway. The driver felt the steering go slightly sloppy, so started to slow down; however the rev counter shot up even though he was decelerating. After travelling less than 1 mile from the initial suspected fault, the driver pulled over on to the hard shoulder, stopped the vehicle and climbed out of the cab once he had established that it was safe to do so. At this point it was evident that the wheel on the near side drive axle was missing and the second wheel was sitting at an angle. The wheel nuts on the wheel hub had come away completely leaving the studs in place. The wheel was never found.

Following an independent analysis of the remaining wheel studs, the report is inconclusive. The likely cause is both stud stretching, caused by historical over tightening when wheels are changed or worked on, combined with corrosion between the two faces of the drive axle wheels.

- The driver carried out his pre-start checks - Do drivers meticulously check wheel nuts when they carry out their pre-start checks? Are they trained and aware what to look for? Are vehicle checks documented by drivers and monitored by line managers to ensure defects are repaired in a timely manner and any trends are identified?
- The driver also walked around the vehicle to check the basics whilst at a customer site – Do drivers utilise the time when at a delivery point to carry out general spot checks on their vehicle?
- There is a wheel re-torque procedure in place - Are there processes in place when a wheel/tyre is changed to ensure it is initially torqued correctly using a calibrated wrench and then re-torqued at the appropriate interval? Are these processes

followed?

- The facing plates are cleaned each time a wheel is removed – Is there a process in place to ensure that facing plates are cleaned every time a set of wheels is worked on.
- The vehicle was fitted with wheel nut movement indicators – It is a company requirement that wheel nut movement indicators are fitted to LGV wheels to compliment, rather than replace, robust maintenance programmes.
