# Fatal 1 - Defective isolator on a Warrior 1400 Powerscreen and the importance of following LOTOTO process

LOCATION:	QUARRY	ALERT STATUS:	Normal
ACTIVITY:	GUARDING AND ISOLATION	DATE ISSUED:	19/09/2024 13:38:14
SUB ACTIVITY:	NO SUB ACTIVITY AVAILABLE	INCIDENT No:	04833

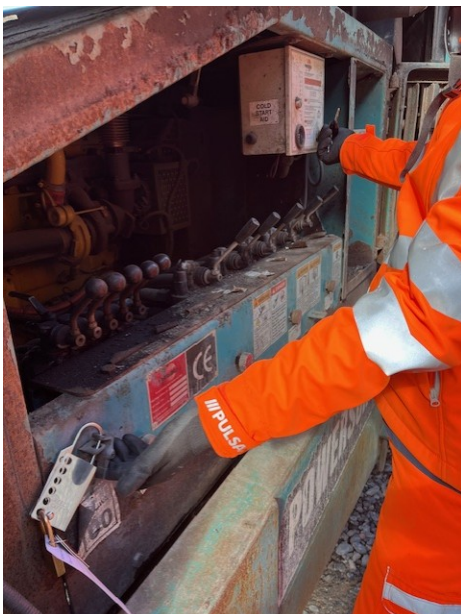
An isolation was required to allow a conveyor belt to be replaced on a Warrior 1400 Powerscreen. When following the LOTOTO process the isolation owner applied a hasp, padlock, and tag to the main isolator. However, during the try-out step it was discovered that turning the isolator only a few degrees allowed the engine to be started. The make of the isolator was Cole Hersee.

The images below show the isolator, the isolator with the hasp and padlock fitted, and operator demonstrating that the conveyor could be started when isolator turned a few degrees with hasp and padlock fitted.

On identifying the issue the work was stopped, the equipment made safe, and the isolator will be replaced.

- Following the **LOTOTO** process in full is **essential**.
- The Try-Out step in this case identified an issue with the isolator.
- Use this briefing note to reaffirm the importance of LOTOTO process and in particular, the Try-Out Step.
- Identify any Cole Hersee isolators on your site and test them to ensure they are in working order and that isolation can be carried out effectively. If not, replace them with one that meets our company's specification.
- Resources to support the sharing of key safety messages in relation to '**Fatal 1 - Contact with moving machinery and isolation**' can be reviewed and downloaded from the [Fatal 1 section of Safequarry](#)
