Fatal 1 - Defective isolator on a Warrior 1400 Powerscreen and the importance of following LOTOTO process

LOCATION:	QUARRY	ALERT STATUS:	Normal
ACTIVITY:	GUARDING AND ISOLATION	DATE ISSUED:	19/09/2024 13:38:14
SUB ACTIVITY:	NO SUB ACTIVITY AVAILABLE	INCIDENT No:	04833

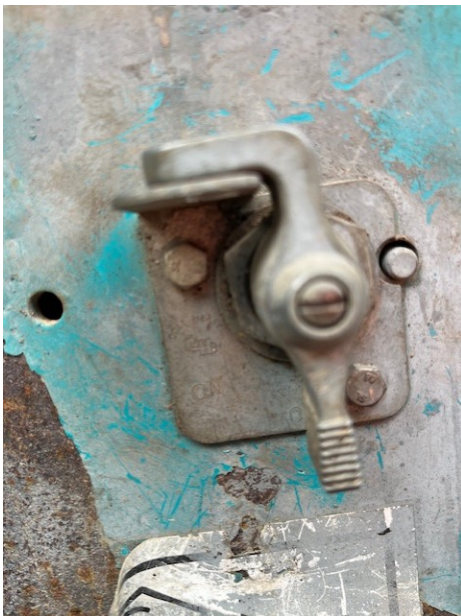
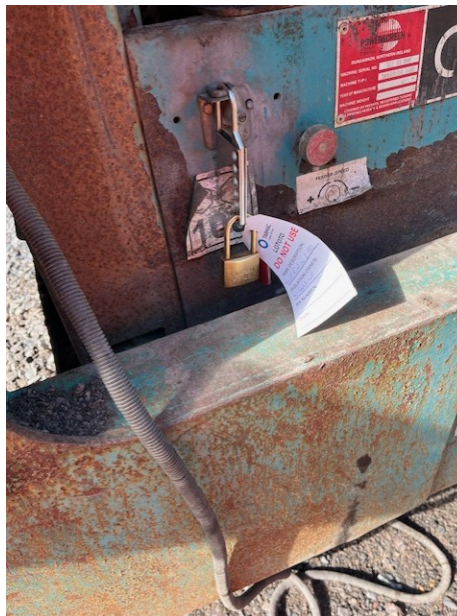
An isolation was required to allow a conveyor belt to be replaced on a Warrior 1400 Powerscreen. When following the LOTOTO process the isolation owner applied a hasp, padlock, and tag to the main isolator. However, during the try-out step it was discovered that turning the isolator only a few degrees allowed the engine to be started. The make of the isolator was Cole Hersee.

The images below show the isolator, the isolator with the hasp and padlock fitted, and operator demonstrating that the conveyor could be started when isolator turned a few degrees with hasp and padlock fitted.

On identifying the issue the work was stopped, the equipment made safe, and the isolator will be replaced.

- Following the **LOTOTO** process in full is **essential**.
- The Try-Out step in this case identified an issue with the isolator.
- Use this briefing note to reaffirm the importance of LOTOTO process and in particular, the Try-Out Step.
- Identify any Cole Hersee isolators on your site and test them to ensure they are in working order and that isolation can be carried out effectively. If not, replace them with one that meets our company's specification.
- Resources to support the sharing of key safety messages in relation to '**Fatal 1 - Contact with moving machinery and isolation**' can be reviewed and downloaded from the [Fatal 1 section of Safequarry](#)
