# Fatal 5 - A loaded trailer uncouples and nearly causes a serious or fatal injury to operator - captured on a dramatic video

LOCATION:	CONSTRUCTION/DELIVERY SITE	ALERT STATUS:	Normal
ACTIVITY:	TRANSPORT & LOGISTICS / DELIVERY	DATE ISSUED:	27/11/2024 19:29:26
SUB ACTIVITY:	DELIVERING CONCRETE PRODUCTS	INCIDENT No:	04846

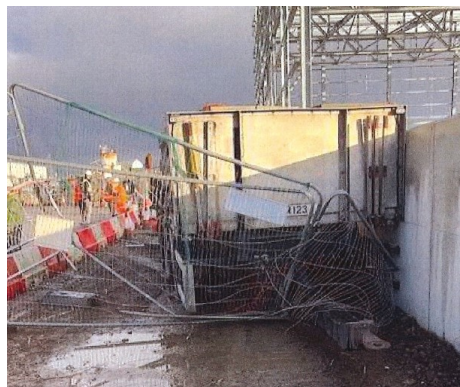
After loading concrete blocks onto a drawbar vehicle (known also as wagon and drag), the contractor driver exited site and seconds after, the rear trailer became uncoupled and narrowly missed a third party person who was working on an adjacent construction site.

The images below show the site before and after the incident occurred. Anyone in the path of the trailer when the incident occurred could have easily been killed

- The likely cause was the red safety interlock not being engaged correctly, causing the pin to work its way loose.
- A similar issue was previously identified by a competitor, who found that operating the vehicle with the coupling in the open position allowed dirt and debris to prevent the interlock from closing.
- Ensuring drivers are correctly trained in coupling and uncoupling, and the importance of the safety interlock being engaged.
- Considering a 10 weekly independent inspection of the coupling equipment or following the manufacturer's recommendations.
- Available technology in the cab can warn the driver if the coupling is open, including audible alarms.

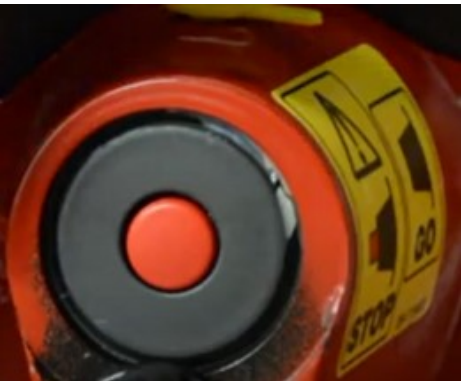
- Regular cleaning and lubrication: Clean and lubricate the coupling weekly. This helps prevent wear and tear and ensures smooth operation.
- Visual Inspections: Ensure daily visual inspections to check for deformations, cracks, or other damage. Pay special attention to the locking pin, drawbar, drawbar eye, drawbeam, endplates and guiding funnel. Follow the manufacturers guidelines.
- Wear Measurements: Regularly measure wear on the coupling equipment, including the bolt dimensions and wear plates. Use equipment such as wear gauges to ensure dimensions remain within the manufacturers specified limits.
- Functional Checks: Test the locking pin function and ensure it operates correctly. For remote-controlled couplings, check the indicator lights in the cab (red/open, green/ closed)
