TRANSPORT - Shovel loader struck the boot hopper on a radial conveyor

QUARRY

AGGREGATE PROCESSING

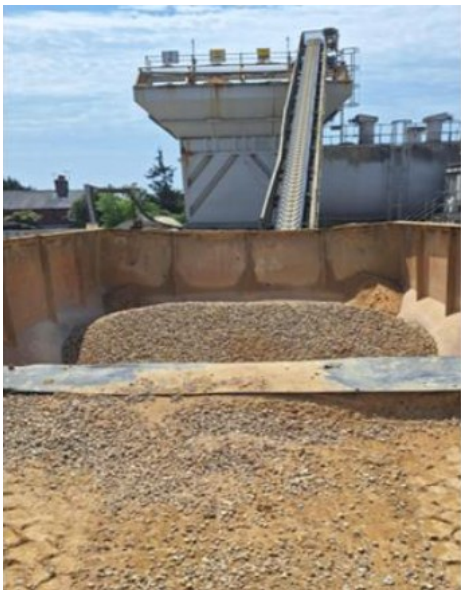
Whilst loading sand into a radial conveyor boot hopper, the bucket of the shovel loader struck the rear wall of the boot hopper. The investigation has identified that the wheel stop which is designed to prevent the shovel loader driving too far onto the boot hopper had been compromised by a buildup of spilt material. This spilt material in effect created a ramp that allowed the shovel loader to drive too close on to the fixed plant resulting in the shovel loader striking the fixed plant. The image below shows the approach to the boot hopper where one can see the build-up in front of the stop wall.

- Are protective devices are working, effective and have not been compromised?
- Is adequate housekeeping being undertaken with spillages cleared?
- What is changing over time that may not be obvious?
- Are site conditions deteriorating over time?

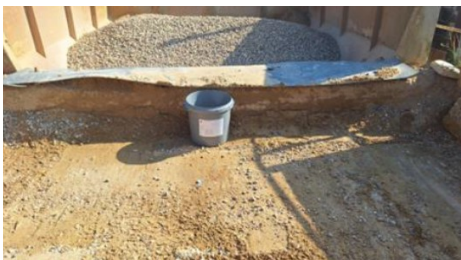
This image below shows the approach to the hopper once the spillage had been cleared (Note: height of bucket is 45 cm).
