# Fatal 5 - Bitumen pipe failure causes loss of hot bitumen at asphalt plant.

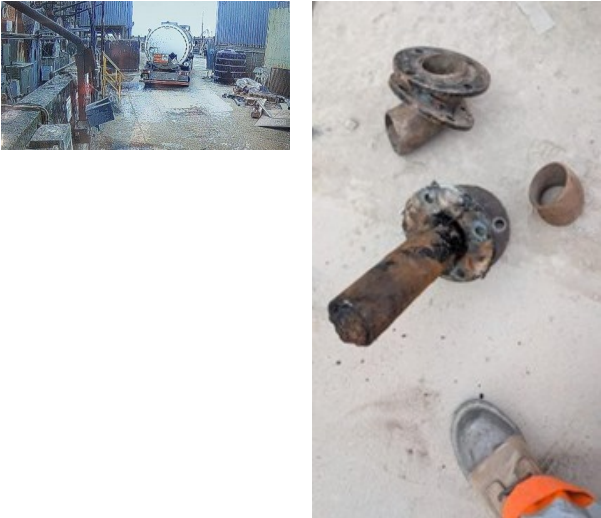
Bitumen (an aggregate binder used in asphalt stored at 150?) was being pumped from the asphalt plant back into the storage tank when a pipe burst and sprayed bitumen, no one was injured. Immediately prior to the incident the bitumen storage tank was switched and pipework changed. The failure occurred on an exposed non-insulated bend in the pipework which had a blockage causing the pipe to rupture. A visual inspection was completed prior but a full management of change considering all the p The first image below captures the moment the pipe ruptured and began to spray the tanker and the ground, and the second shows the section of the pipe where the blockage occurred.

- Management of change process should be followed, and all potential hazards considered as part of the changes.
- Review the 'Guidance for Safe Bitumen Tank Management' available on Safequarry
