HV cable damaged during the feeding in of stock stone

QUARRY

04969

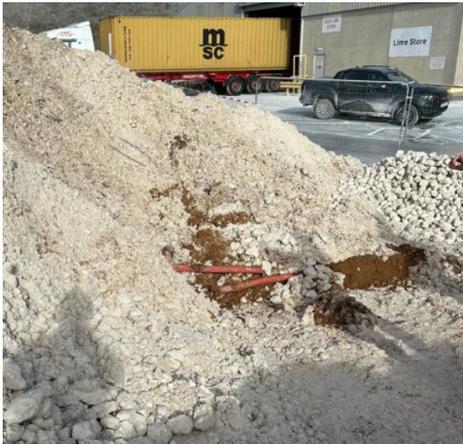
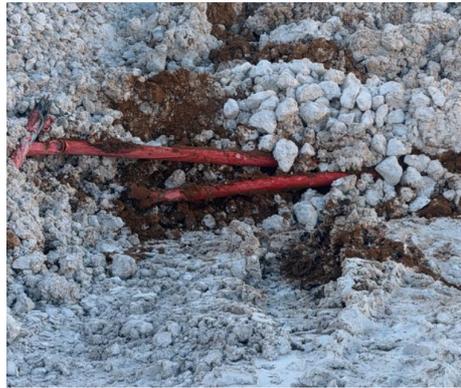
A wheeled loading shovel was collecting stock stone and feeding this into the process plant. As part of this process, the wheeled loading shovel then scrapes the haul road and pushes the material to the side at the bottom of the hill before collecting more stock stone and repeating the process. It is believed that during the scraping process of the road the bucket has damaged the high voltage cable.

The road had been widened historically without the knowledge of the buried HV cables.

- Conduct a scan of the entire site to identify all buried cables and utilities.
- Sign and mark locations of all buried cables and utilities.
