Fatal 1 – Fatal machinery crush incident on conveyor system – MP Connect Alert

LOCATION:	OTHER	ALERT STATUS:	Normal
ACTIVITY:	GUARDING AND ISOLATION	DATE ISSUED:	27/04/2026 13:36:10
SUB ACTIVITY:	NO SUB ACTIVITY AVAILABLE	INCIDENT No:	04971

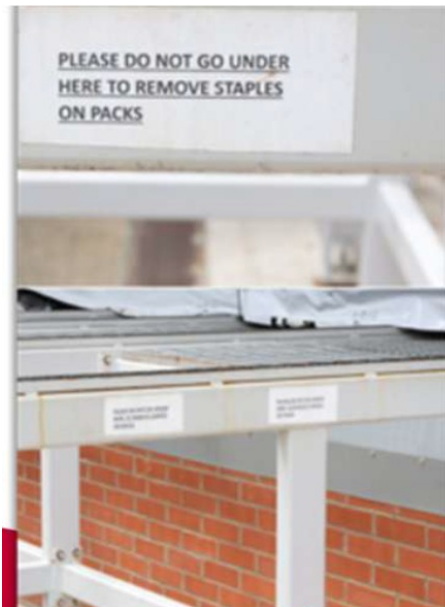
- Access to a dangerous part of machinery was routinely occurring, despite the company being aware of the unsafe practice.
- The company relied on signage and instruction alone to prevent entry into the conveyor danger zone.
- CCTV evidence showed operative accessing the conveyor framework on at least 19 occasions in the weeks leading up to the incident.
- No close or distance guarding was in place to prevent access.
- The system of work required employees to access dangerous parts of the conveyor to remove packaging.
- This system was only changed after the fatality.
- The company was fined £2.2??million plus costs

The image below shows the signs that were on the conveyor system.

- Undertaking suitable and sufficient work equipment risk assessments.
- Applying the hierarchy of control, prioritising engineering controls over instruction.
- Designing tasks to eliminate the need to enter danger zones.
- Implementing clear and effective safe systems of work for normal operation, cleaning, and maintenance.
- Using robust machinery isolation (LOTOTO).
- Providing effective training.
- Ensuring active supervision.
- Encouraging a positive reporting culture, enabling employees to raise concerns or near misses.

- Review PUWER risk assessments for all machinery, focusing on foreseeable non-routine tasks.
- Confirm the hierarchy of control is properly applied, with guarding and other physical controls in place.
- Audit guarding arrangements to ensure dangerous parts cannot be accessed.
- Verify LOTOTO procedures are robust, understood, and consistently applied.
- Check systems of work are clear, concise, and followed in practice.
- Strengthen supervision and routinely verify workforce understanding of risks and controls.
- Promote and act upon near-miss and hazard reporting.
