Faulty aeration valve causes silo over pressurisation.

LOCATION: CONCRETE PRODUCTS PLANT
ACTIVITY: SILO DELIVERIES AND MAINTENANCE
SUB ACTIVITY: NO SUB ACTIVITY AVAILABLE

ALERT STATUS: Normal
DATE ISSUED: 30/04/2026 20:20:17
INCIDENT No: 04973

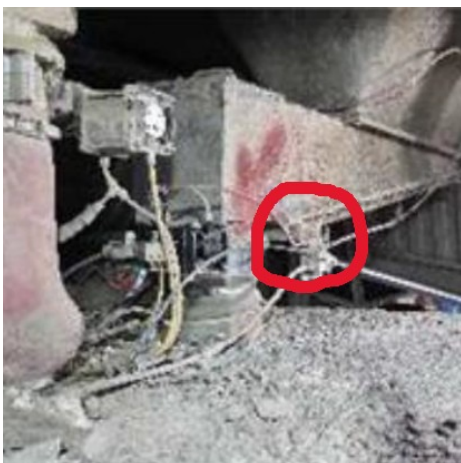
The image below shows the pneumatically controlled aeration valve which is designed to only operate during cement discharge to weigh gear, it failed in open position allowing a constant airflow into the silo.

They found that the reverse-air filters were completely blinded, but the safety systems, including the PRV and over pressure alarm, had activated, preventing any damage to the silo. Further checks found a pneumatic control aeration valve at the silo base had failed to the open position, constantly feeding compressed air into the silo, blinding the filters, causing silo to over-pressurise, and activating the PRV and alarms. This valve was replaced with an electrically controlled valve that can only fail in the closed position.

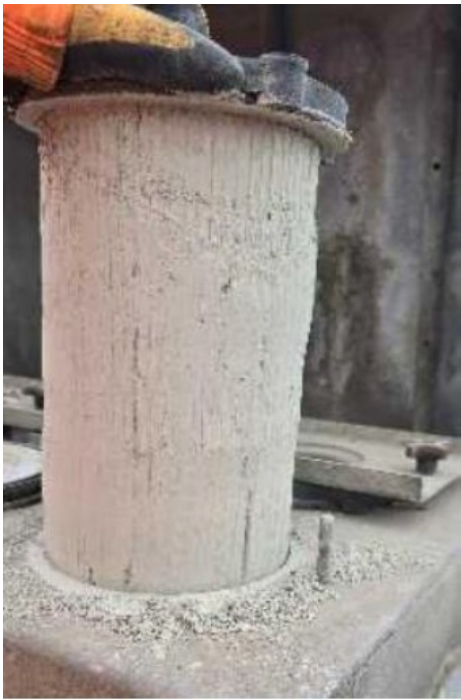
This image shows the silo filters which were completely blinded by agitated cement resulting in over pressurisation alarm sounding and PRV lifting.
