# Customer's employee struck by reversing lorry

ALERT STATUS: Normal  
DATE ISSUED: 27/07/2006  
INCIDENT No: 00098

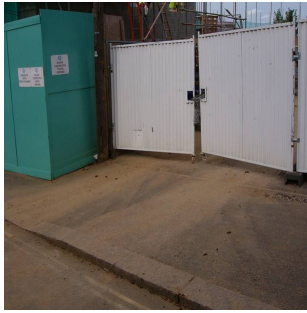
- The driver could not fully see the site employee as he reversed.
- The site employee may not have been fully aware of the risks to health and safety whilst reversing the lorry.
- Site access was very tight, and there is evidence that other vehicles have struck the telegraph pole at the site entrance.
- The site employee may have been too close to the body of the truck as it reversed, resulting in him quickly, and unexpectedly becoming trapped.

Site entrance

- 1) All Hanson drivers must ensure that they can fully see anyone who is acting as a banks-man during reversing operations.
- 2) The customer's health and safety department are investigating this incident and further learning points may be identified at a later stage.
- 3) This incident could have resulted in a much more serious incident had the site employee fell under the wheels of the reversing lorry.
