## BEST PRACTICE

LOCATION:	Quarry	ARTICLE YEAR	2015
ACTIVITY:	Production and Processing	COMPANY:	Hanson UK
SUB ACTIVITY:	Aggregate processing	COMPANY LOCATION:	Cefn Mawr Quarry
BEST PRACTICE No:	BP1947	COMPANY TEL:	07966 499299
COUNTRY OF ORIGIN:	United Kingdom

**Primary crusher wobbler improvement**

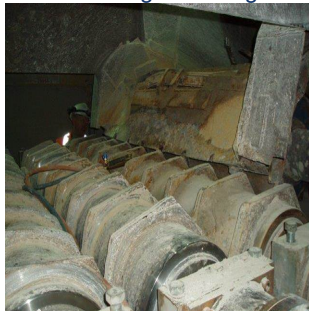
**Before**

In spite of previous improvements made to the wobbler system in the primary crusher at Hanson's Cefn Mawr Quarry, there were 16 wobbler stops during a six month period. These required employee intervention to clear blockages and reset the system. This was a hazardous task in a restricted workspace and resulted in more than 13 hours of lost production.

A root cause analysis, carried out by the quarry team, found that the one metre drop height from the laminator was causing large rocks to stun the wobblers dead. It was decided to remove the first wobbler from the system and replace it with a 30mm reinforced plate, set 500mm from the laminator, to reduce the impact and allow the stone to roll onto the next wobbler. This has been a very successful solution to the problem.
