BEST PRACTICE

| ACTIVITY: | Maintenance & Housekeeping | COMPANY: | Hanson UK |
| BEST PRACTICE No: | BP2003 | COMPANY TEL: | 07971 336578 |

Emergency tyre deflation device

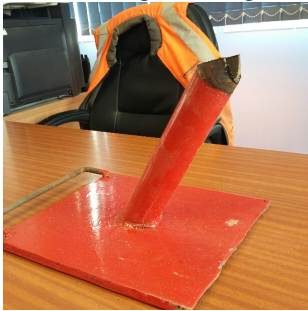
A failure on a tyre fitted to a Volvo ADT dumper caused the inner tube to balloon out of the casing. The tyre needed to be deflated, but due to the potentially weakened structure of the casing, removing the valve manually was not an option.

A spiked device was made consisting of a hollow tube welded to a plate with a hole in it to allow the air to escape. The device was then placed behind the tyre ready for use. Before commencing, a risk assessment and safe working practice was completed for the use of the device in consultation with the tyre company. A second ADT was used as a shield from any potential debris.

The ADT was then reversed onto the spike. This allowed the spike to pierce the tyre and safely deflate.
