## BEST PRACTICE

LOCATION: Asphalt/Coating plant  
ACTIVITY: Access & Egress & Working at Height  
SUB ACTIVITY: N/A  
BEST PRACTICE No: BP2044  
COUNTRY OF ORIGIN:

Fire protection project - baghouse fire

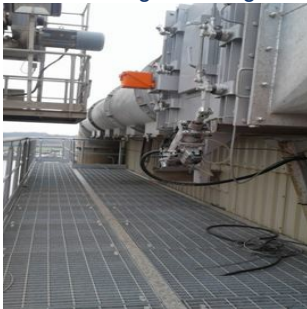
**New walkways**

To prevent any recurrence, remedial work included additional high-level walkways and extra pyrometer probes to alert the plant operator about the conditions in various parts of the plant.
